Alexander NIKITIN, Claude BATHIAS, Thierry PALIN-LUC, Andrey SHANYAVSKIY - Crack path in aeronautical titanium alloy under ultrasonic torsion loading - Frattura ed Integrità Strutturale / Fracture and Structural Integrity - Vol. 10, n°35, p.213-222 - 2015

Crack path in aeronautical titanium alloy under ultrasonic torsion loading

ABSTRACT. This paper discusses features of fatigue crack initiation and growth in aeronautical VT3-1 titanium alloy under pure torsion loading in gigacycle regime. Two materials: extruded and forged VT3-1 titanium alloys were studied. Torsion fatigue tests were performed up to fatigue life of 10^9 cycles. The results of the torsion tests were compared with previously obtained results under fully reversed axial loading on the same alloys. It has been shown that independently on production process as surface as well subsurface crack initiation may appear under ultrasonic torsion loading despite the maximum stress amplitude located at the specimen surface. In the case of surface crack initiation, a scenario of crack initiation and growth is similar to HCF regime except an additional possibility for internal crack branching. In the case of subsurface crack, t

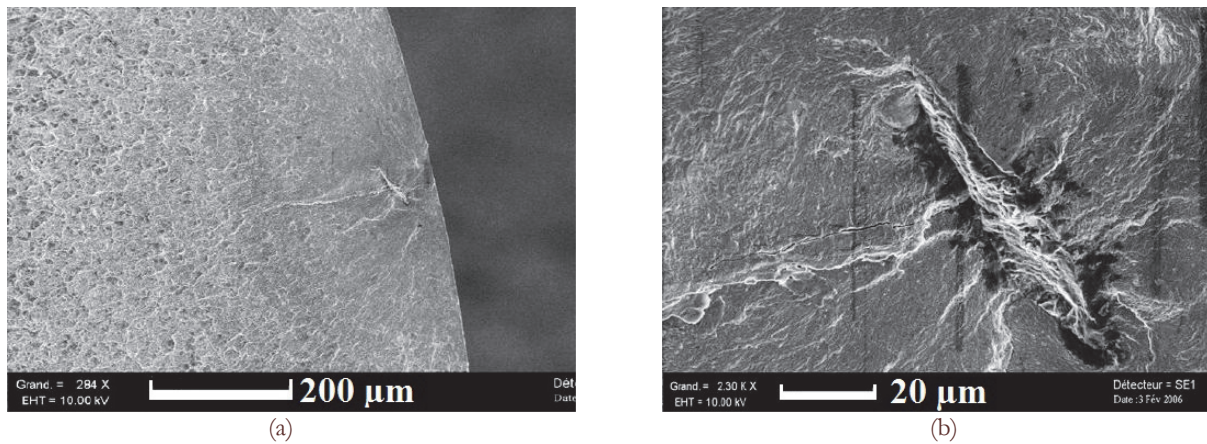
Figure 1: Subsurface fatigue crack initiation in 100C6 steel under ultrasonic torsion, shear stress is 360 MPa, N_f is 10^9 cycles [10].

Results of ultrasonic tests on high-strength aluminum shows that torsion fatigue crack in VHCF regime have a qualitative similarity to crack in HCF regime [9]. It has been shown that crack initiation under torsion is located at the surface of specimen. The first stage of growth is found in the plane of maximum shear stress with further formation of circumferential crack. However, a few years after, it has been shown that under torsion loading in VHCF range as surface, as well a subsurface cracks may also appears if material contains a non-metallic inclusions. In reference [10] high-strength steel was studied up to a fatigue life of 10^9 cycles. In the case of surface initiation, the fracture surface of 100C6 steel shows a similar to HCF 'factory roof' pattern, but in the case of subsurface crack initiation, an initiation mechanism is more similar to push-pull fatigue. In this case a 'fish-eye' pattern is formed around an elongated non-metallic inclusion, fig.1b. The torsion fatigue crack does not show a significant branching and 'factory roof' fracture is absent, fig.1a. Unlike high-strength aluminum, a 38MnSV5S steels shows a surface crack initiation on the plane of maximum normal stress (45° by the specimen's axis) [11] and further propagation in inclined (by the specimen's length) plane with tendency to turn back to the maximum shear stress plane.

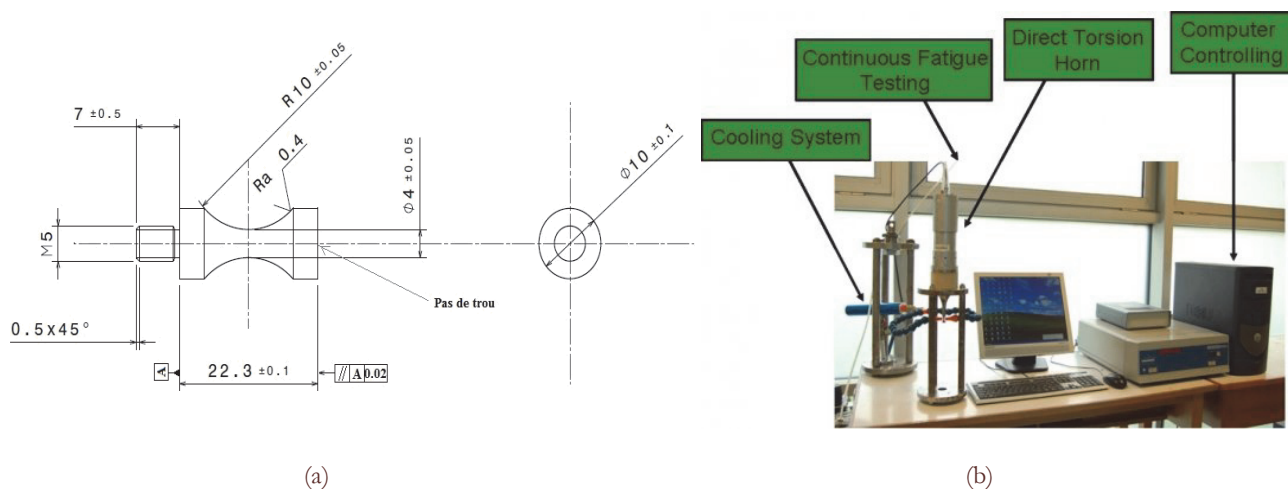
Torsion fatigue tests were performed on specimens, designed according to ultrasonic concept applied to torsion [3, 14] and taking into account dynamic elastic properties of materials at 20 kHz (Tab.2). Specimens made of forged VT3-1 were cut from the rim part of compressor disk along an axis of disk symmetry. Specimens made of extruded VT3-1 were machined from bar so that specimen's longitudinal axis is the same than extrusion direction. Geometry of ultrasonic torsion specimens is presented on Fig.3a. Working section of specimen was polished by emery papers from grade 600 to 1000. Fatigue tests were performed continuously (without pulse - pause) by using a self-designed ultrasonic torsion system [14], (Fig.3b) up to fatigue failure or run out limit of 10^9 cycles. All the tests were performed at room temperature with permanent compressed dry-air cooling. An infrared camera was used for monitoring surface temperature of specimen during fatigue tests. Result shows that there is now significant self-heating effect in VT3-1 titanium alloy under torsion loads [15].

Figure 3: (a) Geometry of ultrasonic torsion specimen and (b) ultrasonic torsion testing system.

The calibration of the testing system was performed with strain gauge and Vishay conditioning device with a large bandwidth (up to 100 kHz). Calibration shows a perfect linear relation between applied tension and measured deformation.

The fatigue crack under torsion is detected by drop of resonance frequency. This crack detection is done automatically with a high-performance computer feed-back controller. After each test the crack existence is verified by optical microscope.

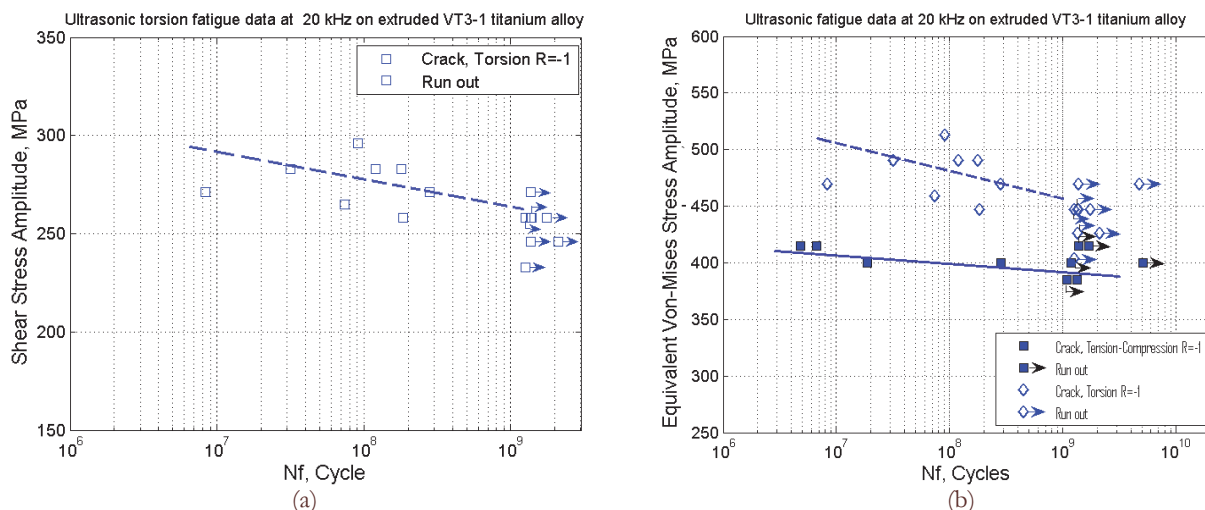
Figure 5: Results of fatigue tests on extruded VT3-1 titanium alloy (a) torsion data in terms of shear stress amplitude and (b) tension compression $R=-1$ and torsion data in terms of Von Mises equivalent stress amplitude.

Like for the forged alloy, the SN curve in torsion for the extruded VT3-1 titanium alloy exhibits a significant slope in VHCF regime, Fig.5a. Since the fatigue tests were stopped around 10^9 cycles, most of the cracks were observed in the fatigue life range below 10^9 cycles. As already was done for the forged alloy, the results of torsion tests on extruded VT3-1

titanium alloy were compared with previous results [17] obtained on the material but under fully reversed tension, Fig. 5b. In terms of Von Mises equivalent stress amplitude, like for the forged alloy, the slope of the SN-curve is more important under torsion than under tension-compression. However, unlike the forged alloy, fatigue strength of extruded titanium is higher (about 50 MPa) in torsion than in tension-compression. This shows that the Von Mises equivalent stress is not suitable to describe the VHCF strength of this alloy. In order to try to explain such mechanical behavior the analysis of the fracture surface was carried out both by optical microscopy and SEM. Unlike tension-compression, where only subsurface crack were observed, in case of torsion load a transition from surface to subsurface crack initiation was found. Comparison of results on forged and extruded titanium alloy (Fig.4 and Fig.5) shows that fatigue strength of extruded titanium alloy is higher compared to the forged one that is in good agreement with mechanical properties of materials (Tab.2).

First of all, the comparison of SN-curves for push-pull and torsion loadings (Fig.4 and 5) shows a more important slope of SN-curve in the case of torsion loading. This tendency keeps being the same as for forged, as well for extruded titanium alloy in spite of small difference of SN-curves for these alloys under push-pull fatigue. This means that VT3-1 titanium is more sensitive to shear stress than to normal one. This is typical for ductile metals. However, long crack propagation is observed in planes of maximum normal stress which is typical for more brittle material. Therefore, at the very first stage of fatigue crack initiation, when a crack length is about the same order than the grain size the fatigue behavior of titanium is similar to ductile material and fatigue damage accumulation is due to sliding process. In the case of two-phase $\alpha + \beta$ titanium alloy a higher capacity to accommodate plastic sliding has a hexagonal alpha-phase. Thus, the fatigue resistance of titanium alloy to torsion loading may be related to features of alpha-platelets. In the case of surface torsion crack it can be observed macroscopically at surface in one of two maximum shear stress planes: along or perpendicularly to specimen’s axis. Fig.8b shows an example of first torsion crack growth stage along an axis.

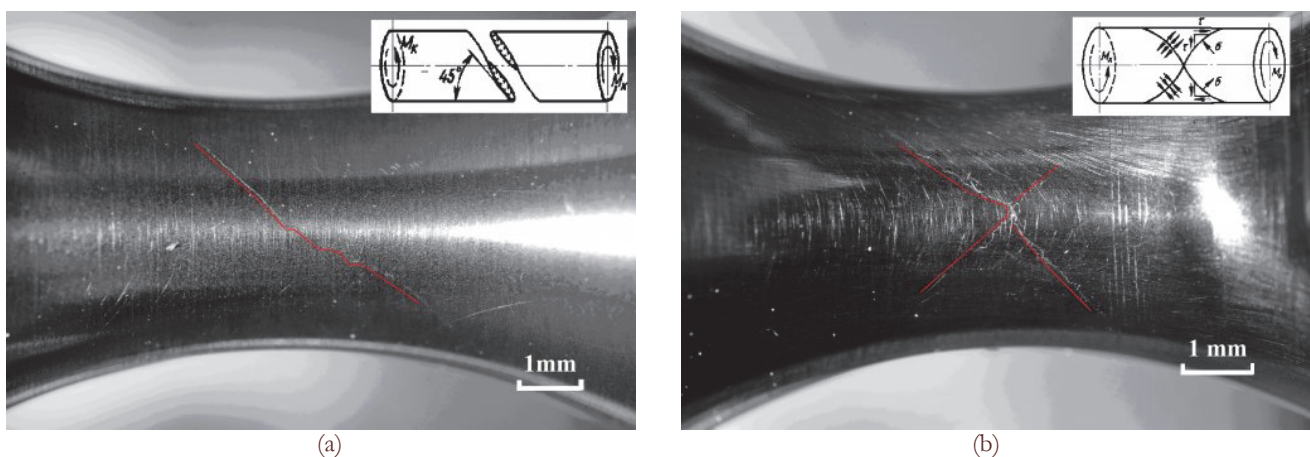
Cracks in torsion specimens were first observed on a lateral surface of specimens by optical microscopy. It was pointed out, that for most of the investigated specimens the first stage of crack propagation was observed on a plane experiencing the maximum shear stress amplitude i.e. perpendicular or parallel to the specimen's longitudinal axis. Further, when the crack became longer it bifurcated (Stage II) and propagated in Mode I on plane(s) of maximum normal stress (i.e. on plane having an angle about 45° with regard to the specimen's longitudinal axis). The propagation of long crack was never observed in the plane of maximum shear stress amplitude up to the final length (corresponding to the end of the test). It should be noted, that crack growth in the plane of maximum normal stress may be found as in a single plane, as well in two planes at the same time (X-type cracks), Fig.6b. This is similar to HCF regime on many metals.

Figure 6: Optical microscopy at the surface of torsion specimens: (a) single crack in the plane of maximum normal stress and (b) two cracks in two 45° orientated planes of maximum normal stress or X-type crack.

Crack growth under torsion loading in the plane of maximum normal stress looks to be quite sensitive to material microstructure. Comparing the surface crack path of extruded and forged titanium alloy it is notable, that branching of the crack is higher for forged titanium alloy represented by less homogenous microstructure. An example of crack path in extruded titanium alloy is showing on the Fig.6a. In this case the crack is quite well orientated on the 45° plane, while in case of forged titanium alloy, Fig.6b, the crack path is more 'zigzag' (alternative branching mode I and mode II). Sometimes crack make a clear 'steps' or even sometimes it is propagating in a two parallel 45° planes.

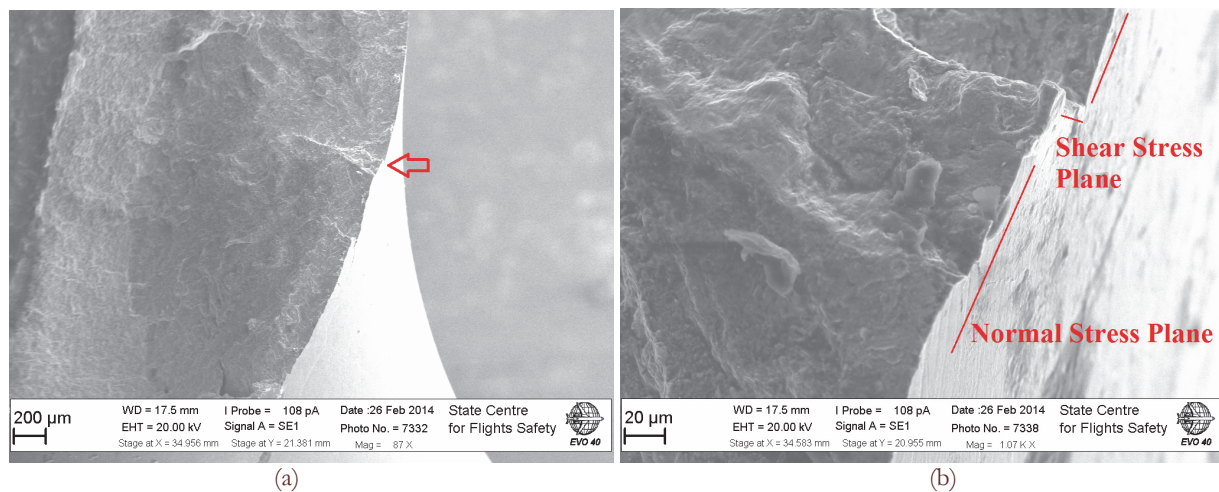
When torsion crack reaches a length of several micrometers, the crack growth turns into a plane of maximum normal stress, Fig. 8b. Typical size of alpha-platelets is very small for the studied titanium alloys and micro-plasticity of alpha-phase is not enough to accumulate fatigue damage at later stage of crack growth that turns fatigue behavior of material to the brittle-mode failure (governed by the normal stress cracking mechanisms). Another reason that can limit the stage of crack growth in shear plane is quite high deformation rate in the case of ultrasonic loading. But anyway, a transition from maximum shear to normal stress plane is typical for torsion cracking at different loading frequencies. In reference [18] fully reversed torsion fatigue tests were carried out on titanium alloy Ti-6Al-4V in HCF regime at a loading frequency of

Figure 8: Surface crack initiation in forged VT3-1 under torsion loading (a) overview of torsion crack with initiation site marked by arrow and (b) detailed crack initiation view.

The microstructure of TiA6V titanium alloy [18] is globular and coarse that is different from present Ti-6Al-4Mo titanium alloy microstructure. Thus, it is difficult to distinguish the role of microstructure and loading frequency on duration of crack growth in shear plane, but it is clear, that this growth stage should be limited by the material capability to accumulate plastic deformation. It has been shown that in the case of HCF a torsion crack first growth in depth of material and after starts to branch at the surface without growing in depth [18]. In the present work on VT3-1 titanium alloy crack tip position versus number of cycles was not monitored and crack shape was reconstructed based on the fracture surface pattern.

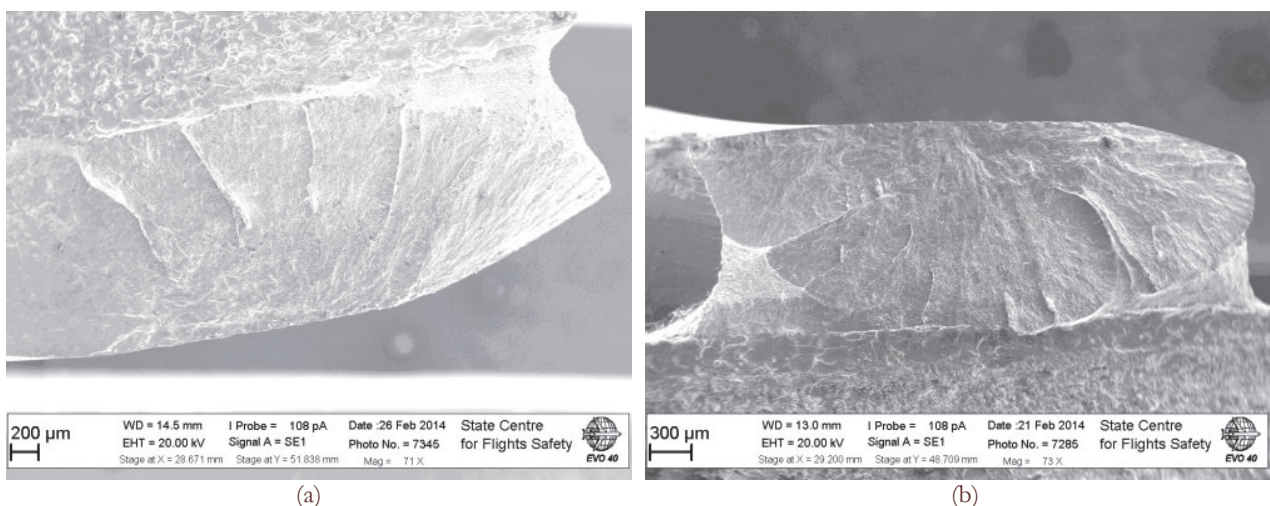
In the case of surface crack initiation a sort of crack branching threshold or critical crack length was found, Fig.9. It seems that at a certain crack length internal crack branching is also possible in the case of VHCF loading that is different from HCF. A slight difference in the fracture surface color in zones before and after branching is due to different roughness that is usually associated with difference in stress intensity factors or crack growth rate.

Figure 9: Fracture surfaces of specimens (a) S=; Nf= (b) S=; Nf=; with clear border of fatigue crack branching.

Unfortunately, a reconstruction of the very first stage of torsion crack growth based on fracture pattern is problematic due to destruction of the fracture surface near the initiation site by friction between crack lips during Mode II stage. Finally, a surface torsion crack in VHCF is similar to HCF growth i.e. it initiates on the maximum shear stress plane and

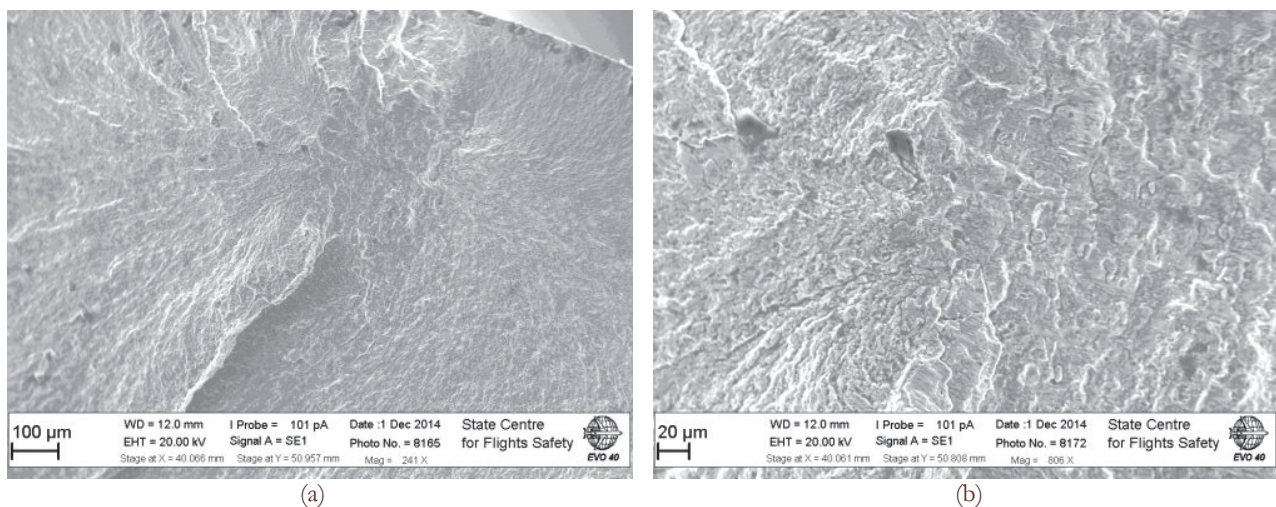
growth in Mode II at the very first stage, but a crack growth bifurcation mechanism seems different for HCF and VHCF. In the case of VHCF branching can be observed in the bulk of material, while in HCF it appears at the surface [18]. Such difference in the branching mechanism may have the same nature with one more interesting feature of VHCF torsion behavior. That is an internal crack initiation under VHCF torsion loading in spite of maximum shear stress located at the surface. An analysis of internal crack initiation site in VT3-1 titanium alloy did not show any structural flaw in the microstructure so that inclusions or clusters of alpha-platelets, Fig. 10. The crack initiation site is significantly destroyed by friction that is clearly seen in Fig.10b. A 'step' at the fracture surface and followed crack growth in two parallel planes means that internal crack is also initiated in the plane of maximum shear stress. After reaching a certain length (that is shorter than the distance from initiation site to surface) the crack branches on the plane of maximum normal stress. Sometimes there is a sort of competition between two maximum normal stress planes that produce a 'wing' like structure at the surface. Excluding this 'wing'-like structures, a further branching is limited in the case of internal crack initiation and no branching 'threshold' (like in case of surface crack) can be found at the fracture surface. In contrary, another notable zone or critical crack length can be reported. As shown in Fig.7b the crack front shape is changing as soon as it arrives at the surface, probably because the stress intensity factor is increasing and consequently the crack growth rate too.

Figure 10: Fracture surfaces of specimens (a) S=; Nf= (b) S=; Nf=; with clear border of fatigue crack branching.
